**Docket No. 217 – Development and Management Plan Inspection**

Northeast Utilities Service Company Certificate of Environmental Compatibility and Public Need for the construction of a 345-kV electric transmission line and reconstruction of an existing 115-kV electric transmission line between Connecticut Light and Power Company's Plumtree Substation in Bethel, through the towns of Redding, Weston, and Wilton, and to the Norwalk Substation in Norwalk, Connecticut.

**Date:** March 29, 2006

**Location:** 345kV Underground Route

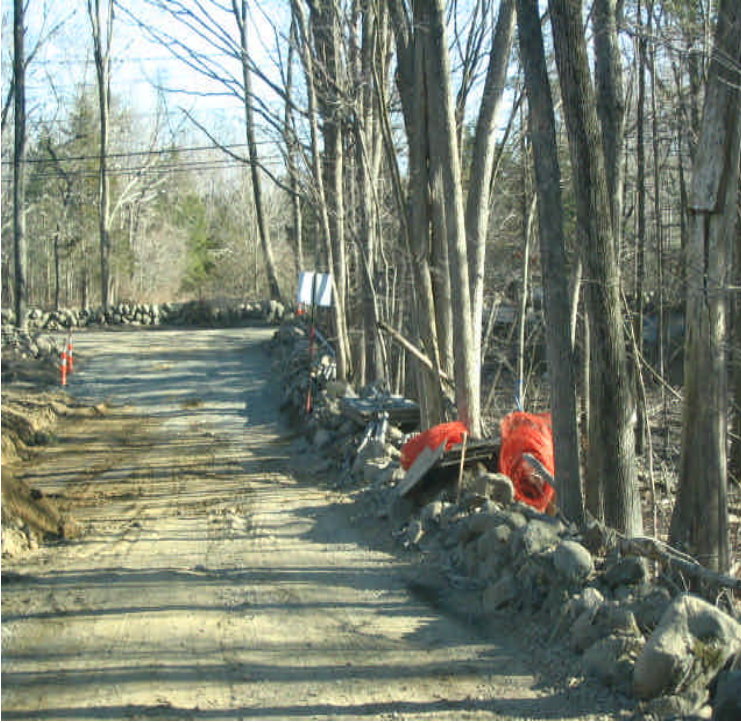
**345kV (Archers Lane and Umpawaug Rd): Photo shows the completed trench work at the access drive to the transition station but a number of materials were left behind on the stone wall. Photo on the right shows where a previously disturbed area was placed with straw mulch. 3/29/06**

<ul style="list-style-type: none"> <li>- Clean up materials left along the stone wall at Archers Lane access drive. 3/29/06</li> </ul>	<ul style="list-style-type: none"> <li>leaks) if they will be used or stored on site. - Check equipment status on a regular basis and keep spill kits on hand.</li> <li>- Report spills immediately, even if they are being controlled.</li> </ul>	
Additional Observations

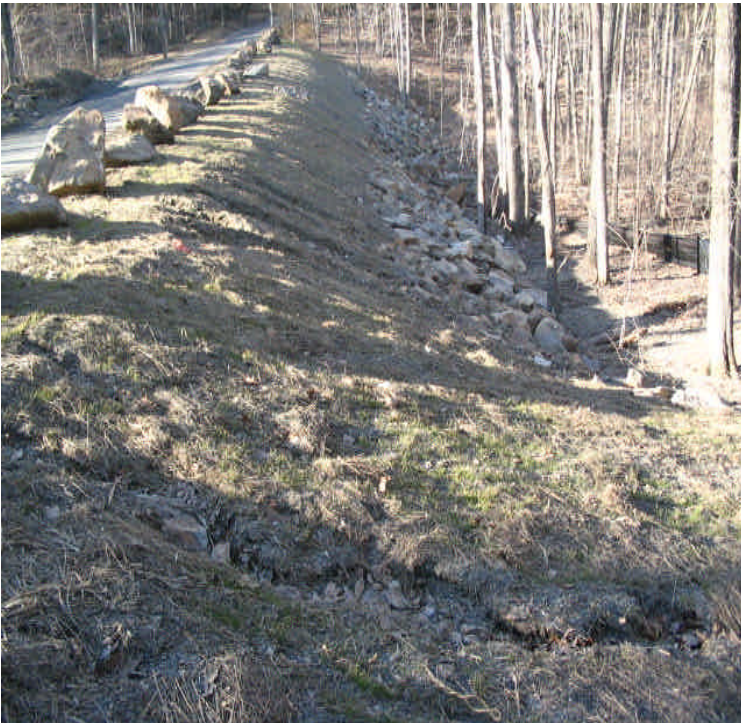
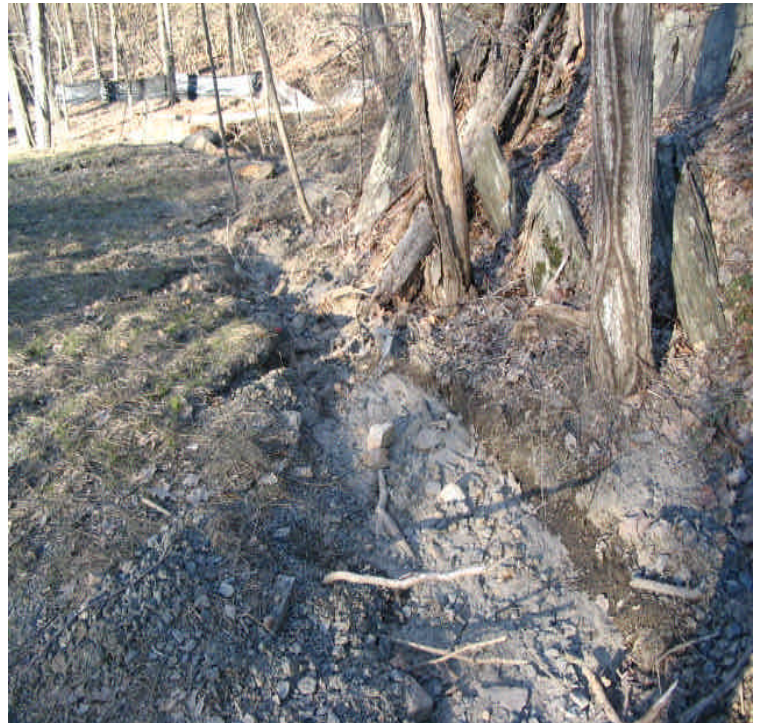
**Photo on the left shows erosive washouts along the slope to the wetland near #79 Umpawaug Rd. Photo on the right shows the most severe washout leading from the road to the stream below at this location. We need to determine whether this slope was built as part of the project. 3/29/06**

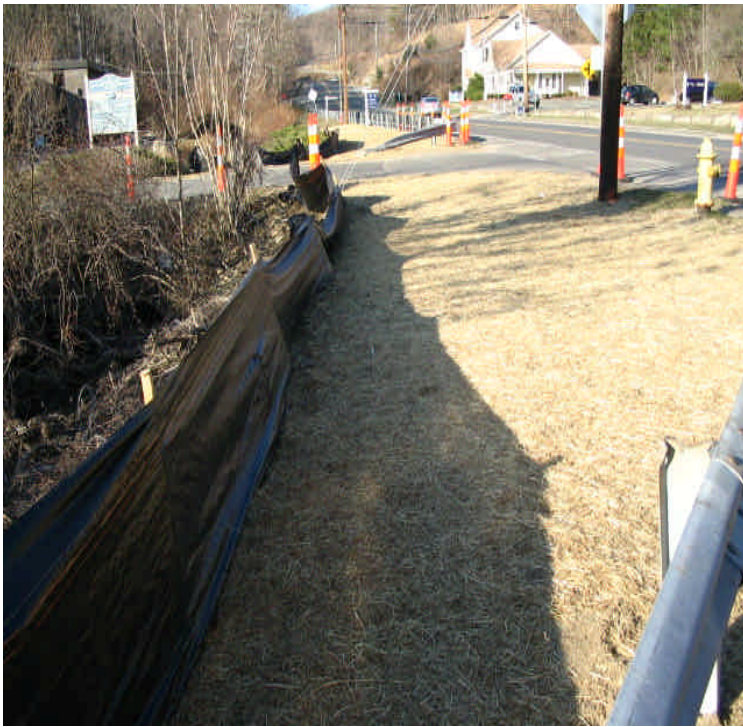
345kV (Rt 107) Photo shows an overview of the area north of Georgetown Deli where the area was well restored and controls are in place. Photo on the right shows the small stockpile remaining where silt fence needs to be extended. 3/29/06

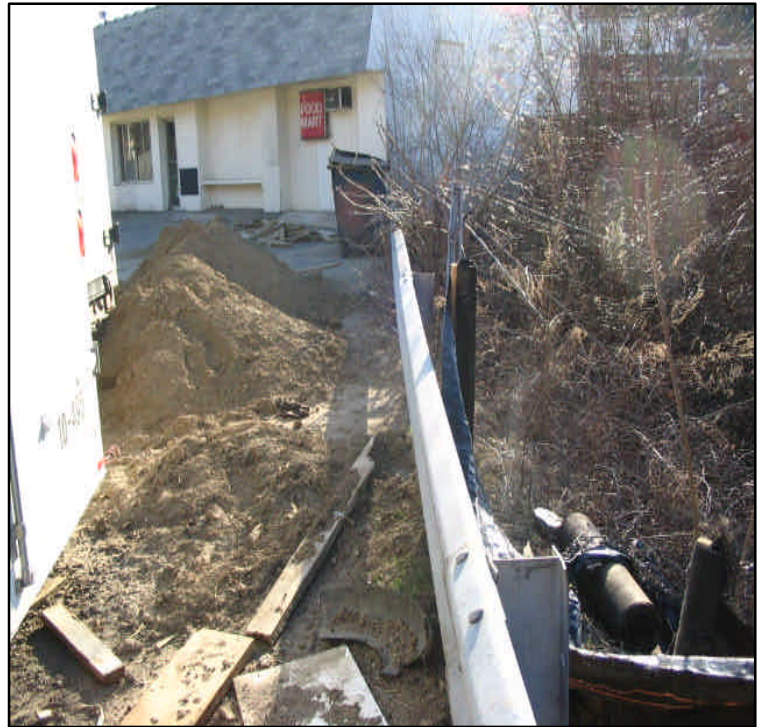
<b>Rt. 107 Daywork</b>	<ul style="list-style-type: none"> <li>- At the Georgetown Deli, adjacent areas are well restored. 3/29/06</li> <li>- A small stockpile still remains here in the parking lot beyond the silt fence. 3/9-3/29/06</li> </ul>	<ul style="list-style-type: none"> <li>-None at this time. 3/29/06</li> <li>- Controls should be extended or this pile should be removed. 3/9-3/29/06</li> </ul>	- The soil pile was moved back from the roadway. Continue to control this area.
<b>Umpawaug Rd.</b>	<ul style="list-style-type: none"> <li>- A stockpile and small storage yard remain in</li> </ul>	<ul style="list-style-type: none"> <li>- Remember to restore these areas when feasible</li> </ul>	- The area and controls were restored.  -The pile is proposed to be removed soon but remained at this time.

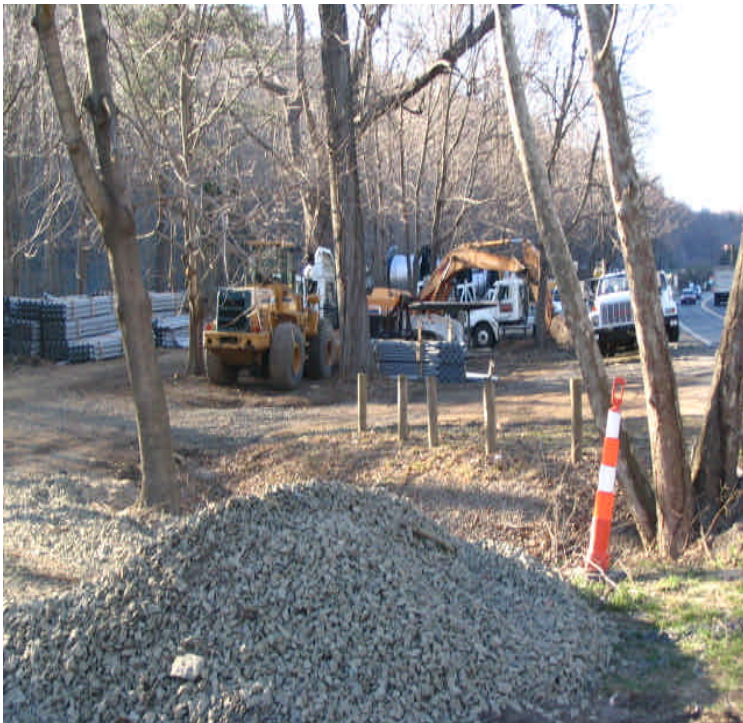
345kV (Route 7) Photo on the left shows the racquet club storage yard. Photo on the right shows an area that has been hydroseeded along the roadway either as a result of the project or unrelated utility work. 3/29/06

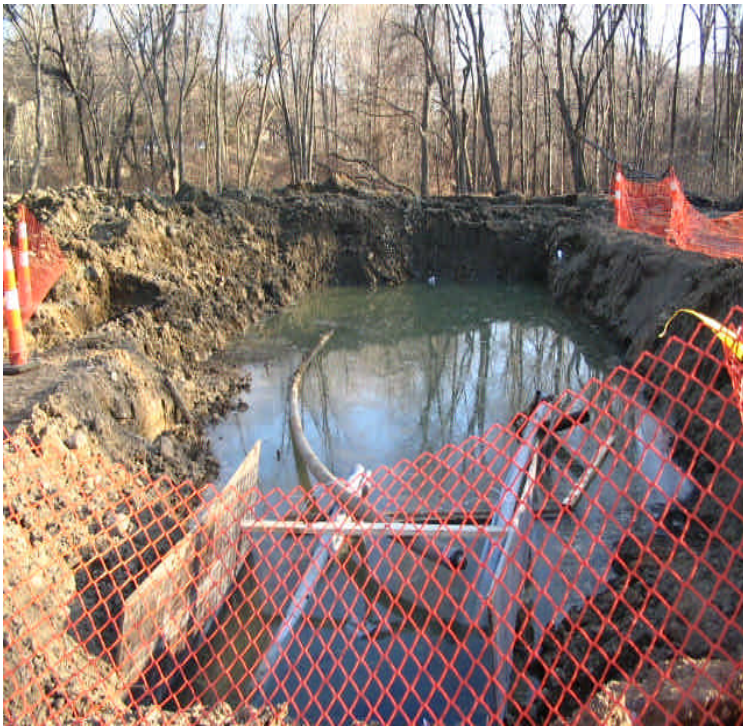
- Excavation was noted at the site at School Rd to connect up with HDD bore. High groundwater was noted in the trenches 3/29/06	- Further restoration will be necessary after the adjacent work is complete. See additional sections for more details. 3/29/06	-N/A until work is complete

**345kV(HDD):** The photo on the left shows a view of the HDD site where trenching resumed in order to make the connection to the bore. Photo on the right shows where some of the sediment to be removed, accumulated in the rocky channels beyond the check dams. 3/29/06

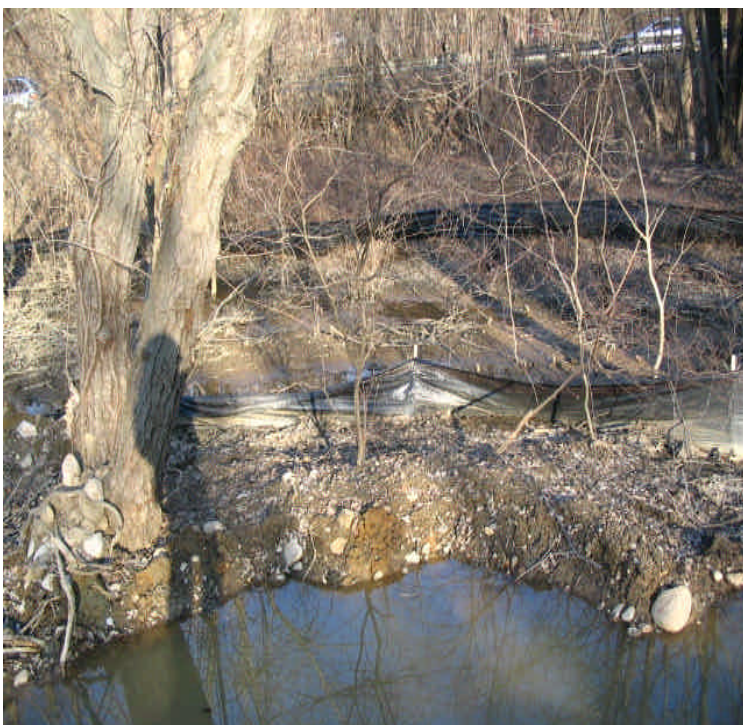
**(HDD and Route 7)** Photo on the left shows the wetlands to the east of the basin beyond the erosion controls where accumulated sediment will also require removal. Photo on the right shows work at Wilton Corp. Park where the stockpile was moved back from the road but the area remains disturbed. 3/29/06

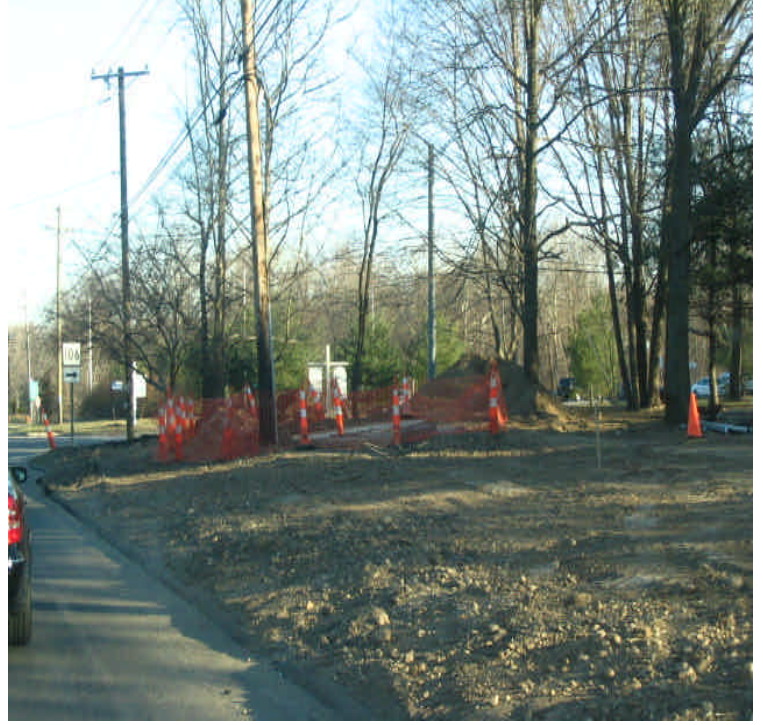
Areas of Inspection	Observation	Recommended Action	Corrected Action
Vault Openings and Trench Construction	- An open vault excavation remains near Wilton Corporate Park on Rt. 7. 3/9-3/29/06	- Some further attention is needed here. See erosion control section. 3/29/06	-The stockpile was moved back from the road but more attention is needed
